THE **BOEING** COMPANY
AERO-SPACE DIVISION
SATURN BOOSTER BRANCH

DOCUMENT NO. T5-6539-80

TITLE METALLURGICAL ANALYSIS OF FILTER HOUSING ASSEMBLY,

60B83104-1, SERIAL NUMBER 69 FAILURE

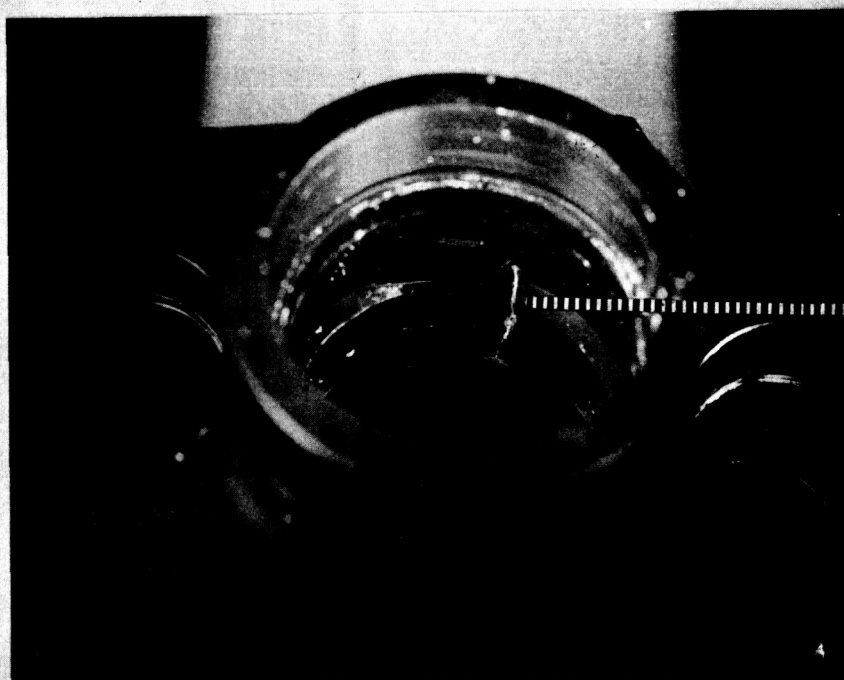
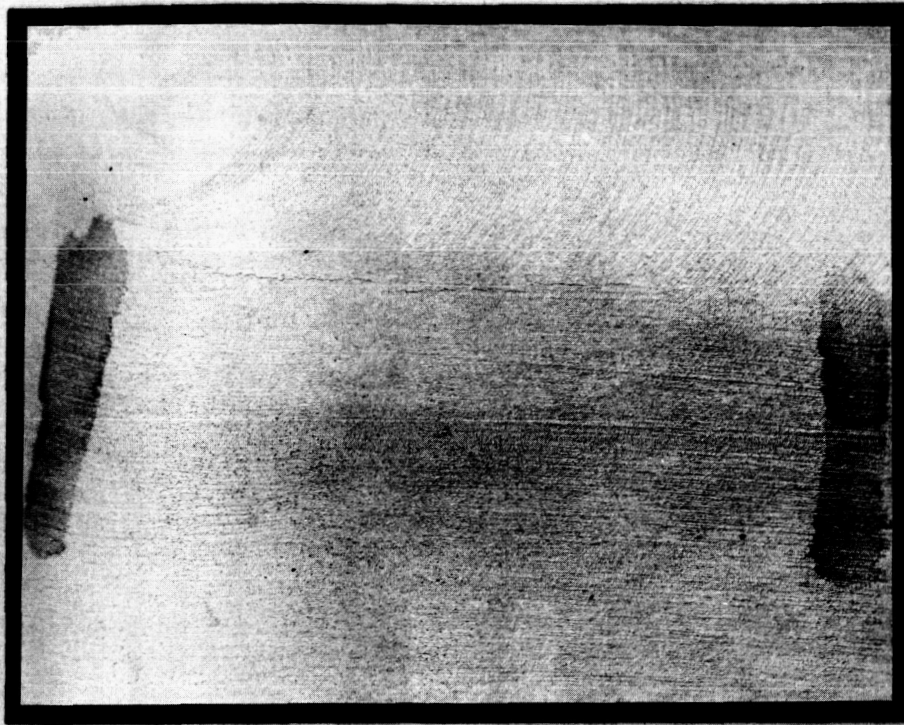
Figure 2 - Results of fluorescent dye penetrant inspection

5.3 Visual examination of the housing found the only defect to be the 7/8 inch long crack on the exterior surface, along with the interior projection of the crack which was about 2 inches long. Penetrant inspection revealed the only defect to be that found by visual inspection. The location of the defect is indicated in view A of figure 1. Figure 2 shows the results of penetrant inspection. Figure 3 shows the exterior surface at the crack location. It is noted that the crack is not continuous. Figure 4 shows the interior surface at the crack location. It can be seen that the failure is a series of cracks all running longitudinally.

A-Exterior view of Failure

B-Interior View of Failure

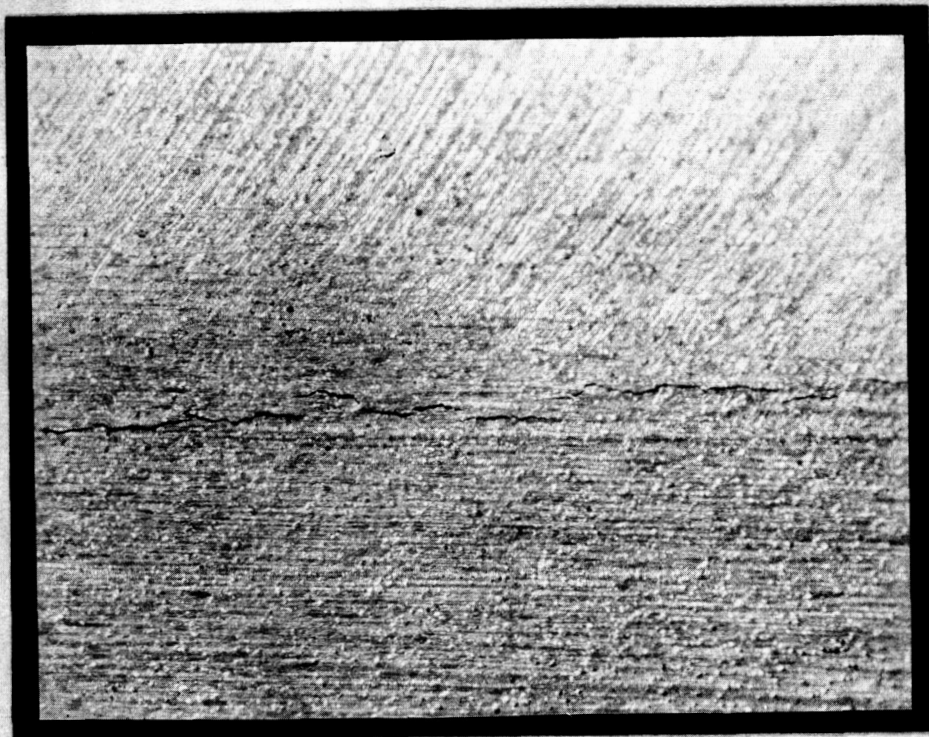
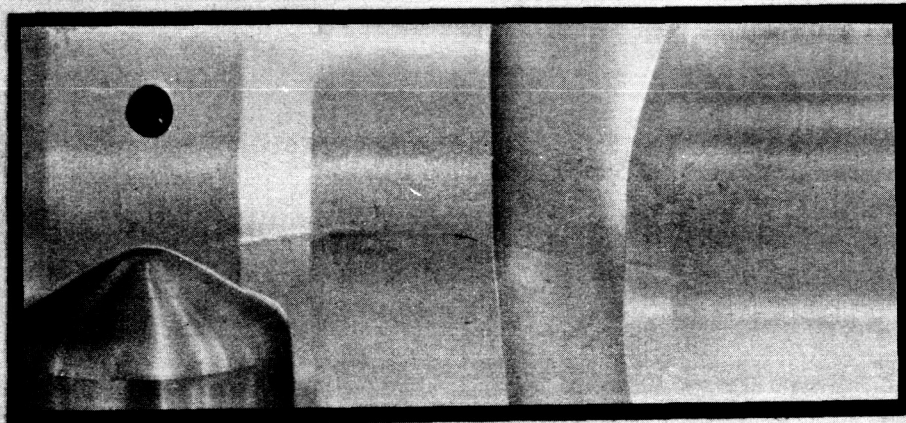
Figure 3 - Exterior Surface of Failure

A - Exterior surface of failure, 4X

B - Portion of exterior surface of failure, 15X

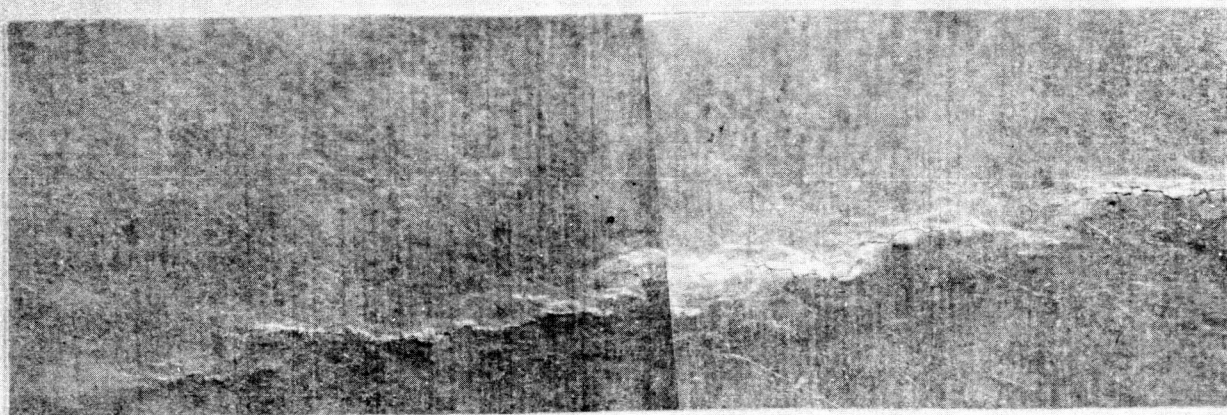
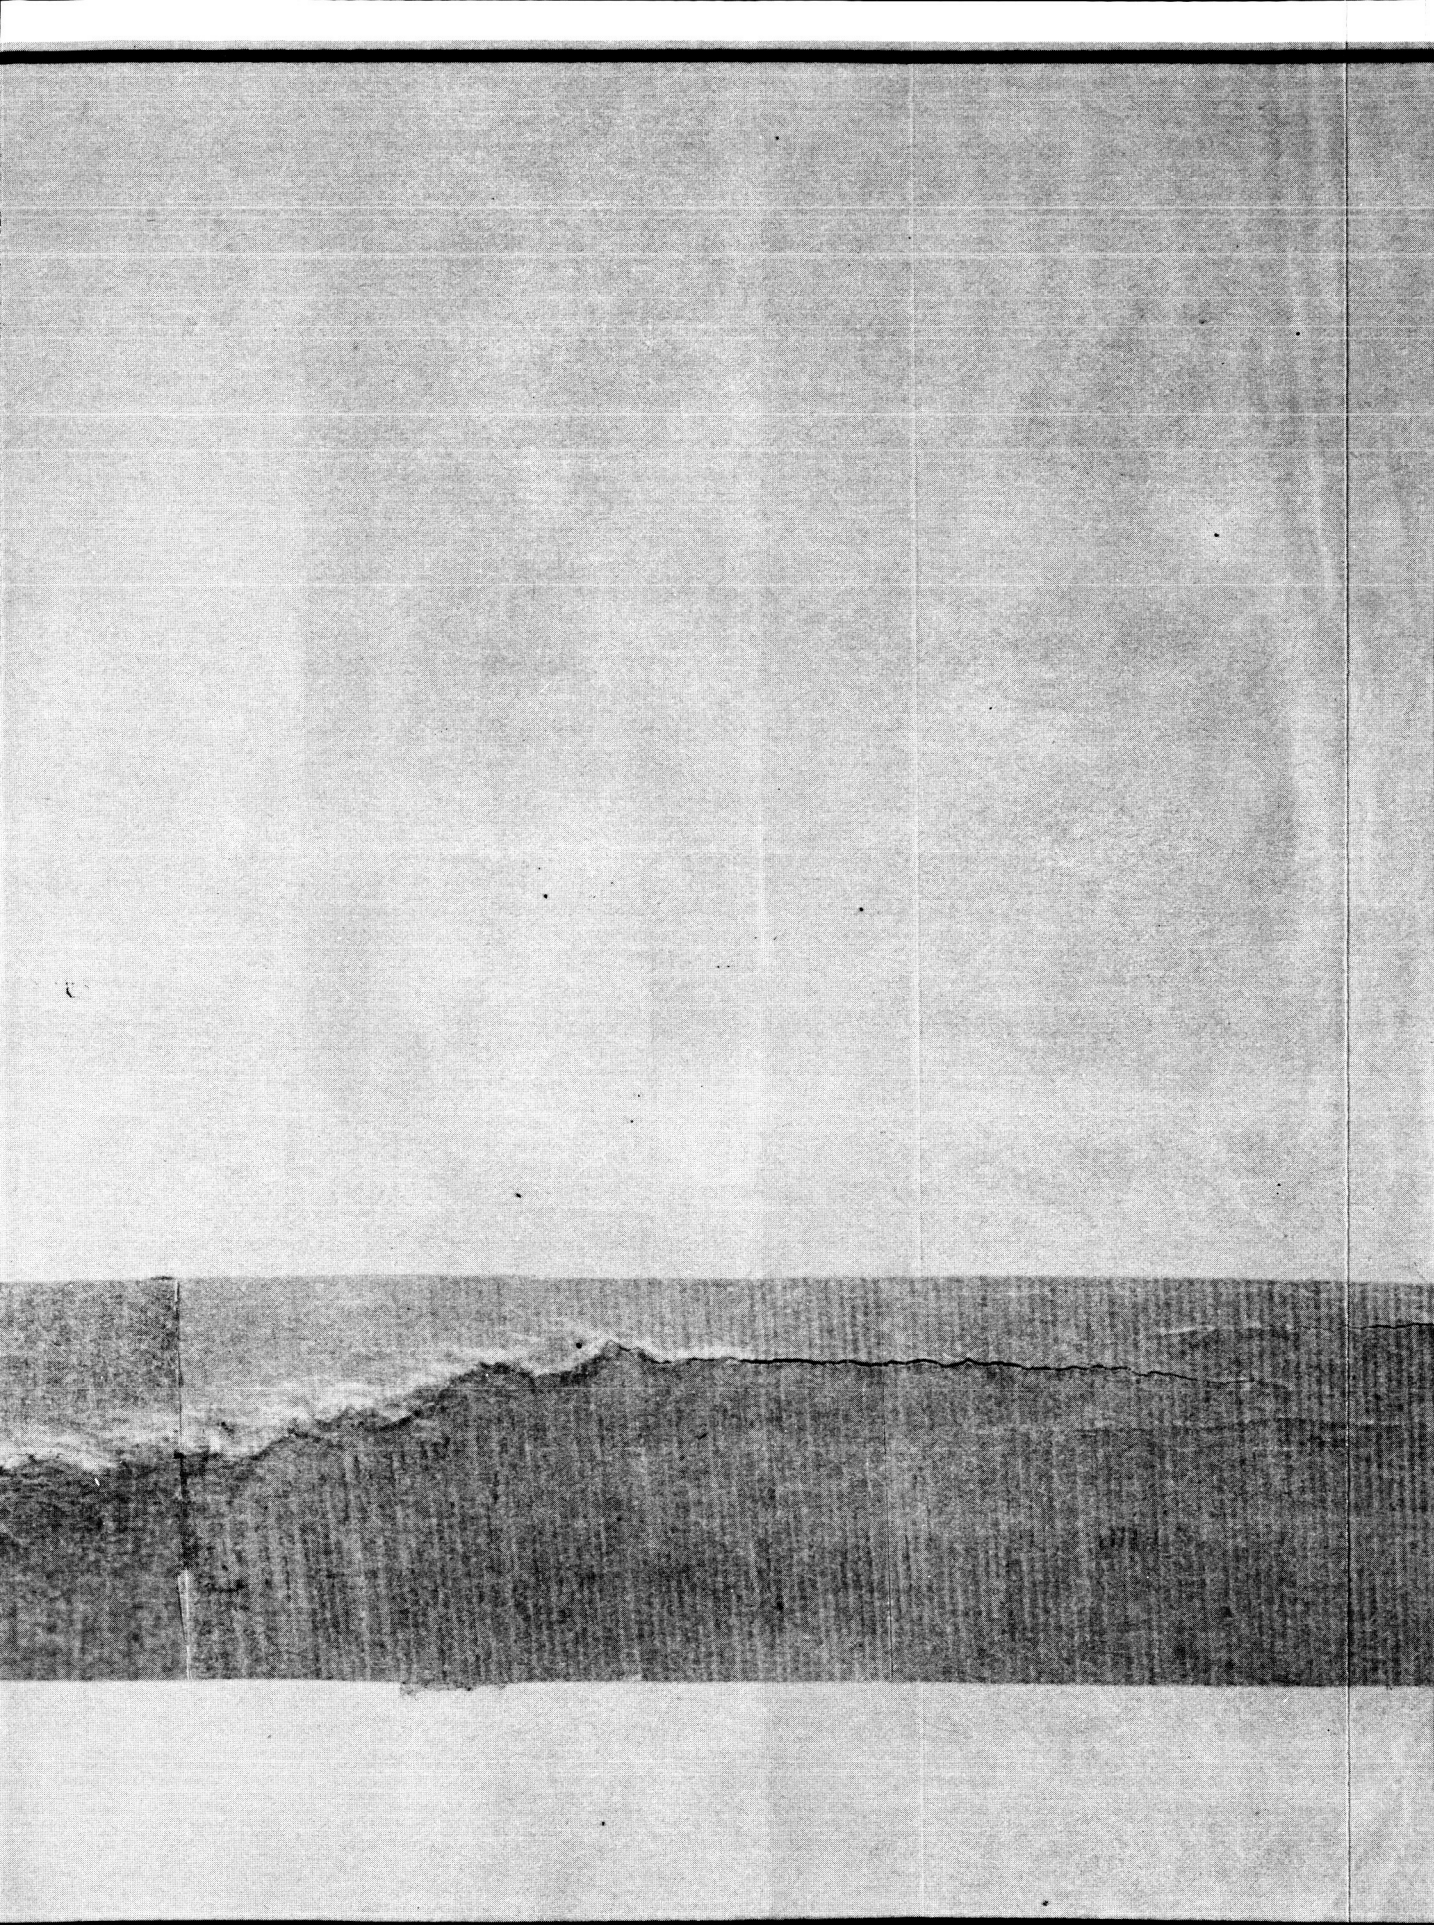
Figure 4 - Interior Surface of Failure

A-1X

B-15X

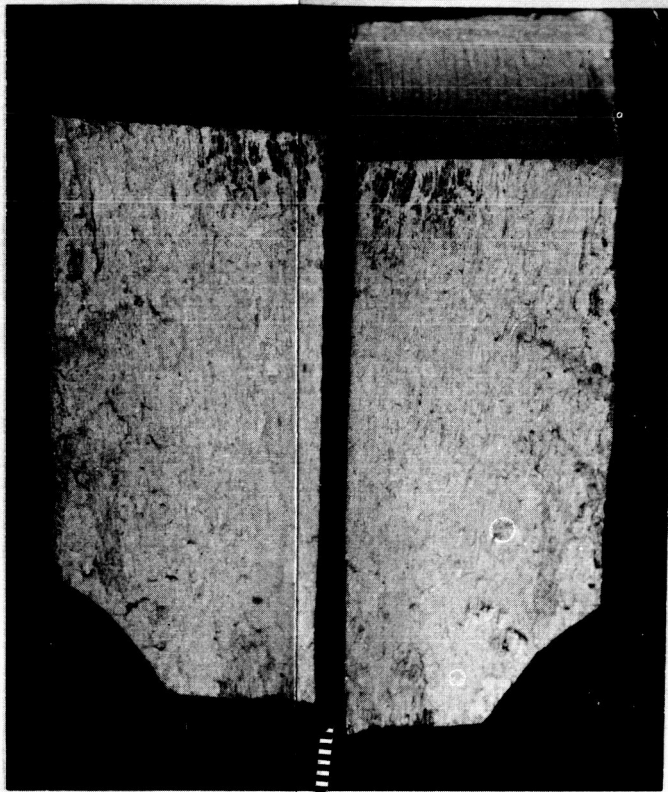
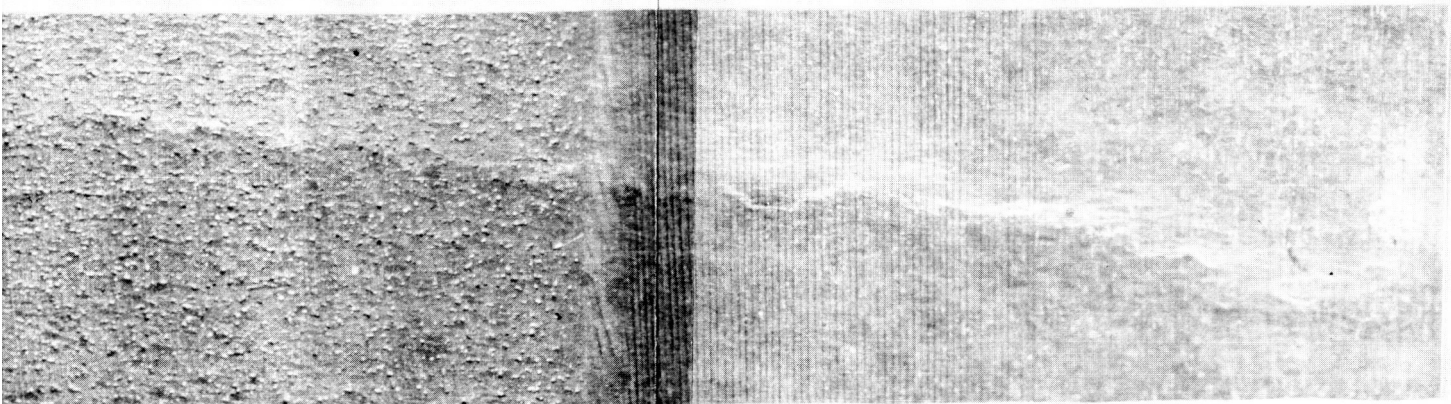
Figure 5 - Fractograph of Portion of Crack, 3X

Figure 5 is a fractograph of a portion of one of the cracks. The initiation point of this crack, on the interior surface of the housing is indicated in figure 5. The fracture face has a granular

exfoliated appearance. It was noted that when this specimen was cut out the remaining cracks closed. This indicates that there was a tensile residual stress in the part normal to the plane of fracture. The appearance of the fracture indicates that failure progressed from the interior of the housing radially outward.

Initiation

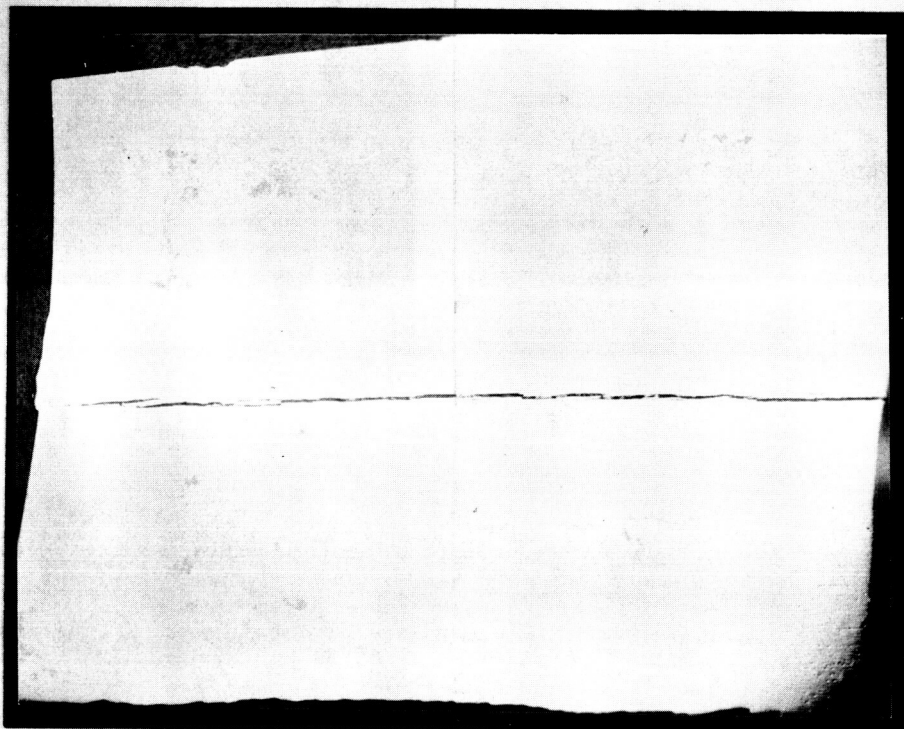
Figure 6 - Radial Microspecimen,
as polished, 6X

Similar results were obtained from the examination of both radial and longitudinal microspecimens. Figure 6 shows the radial microspecimen unetched, while figure 9 shows the unetched longitudinal microspecimen. The microstructure is typical of an aluminum alloy hand forged block not having a great deal of prework. This is evidenced by the failure of some grains to recrystallize and the presence of stringers of agglomerated particles of secondary phases. However, this is not considered unusual for large hand forged blocks. Figures 7 and 8 show the failure in a radial section. This is the short transverse - longitudinal grain direction plane. Figure 10 shows the failure in a longitudinal section. This is the long transverse - longitudinal grain direction plane. Cracking is noted to be intergranular and branching in a plane normal to the short transverse grain direction. Microscopic study revealed a network of cracks and subcracks which comprise the failure. The failure pattern observed is characteristic of stress corrosion cracking.
